BUXTON GORGE NATURAL RESOURCE INVENTORY AND ASSESSMENT

**Stephen W. Coleman
&
Roderick G. Christie**

Spring/Summer 2003

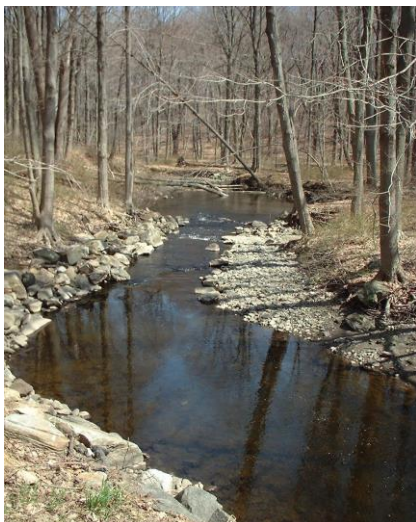
Sampling Site # 1

Physical survey data indicated that Broad brook is typical of so many streams in this area where water temperature and flow are the most limiting factors. Broad brook is a secondary stream that typically has large flows in the spring, but is reduced to a very small flow in summer. Fortunately, there are some deeper pools and undercut banks where trout and other temperature sensitive species can escape the water temperatures associated with low flow. Air and water temperatures for site # 1 were 21 degrees C and 20 degrees C respectively indicating conditions that are suitable for brown

trout but not brook trout. Site # 2 had a similar air temperature but slightly lower water temperature at 18 degrees C. Water temperature decreases as you move downstream. The hemlocks of the Gorge area are effectively shading the stream, thus reducing stream temperatures and benefiting aquatic wildlife.

Mountain bikes and all-terrain vehicles from the 684 rest stop have caused some erosion problems in the areas just south of Buxton Road. Runoff from Buxton road, other roads upstream and possibly other sources is destroying habitat in the upper area of the brook. There are also many areas in the Brook that are directly impacted by garbage dumping from the 684 rest stop. Habitat for macroinvertebrates has been somewhat compromised at site # 1 where rocks are sometimes more than 25% embedded in the bottom. This condition improves as one moves downstream with little or no embeddedness at sample site # 2.

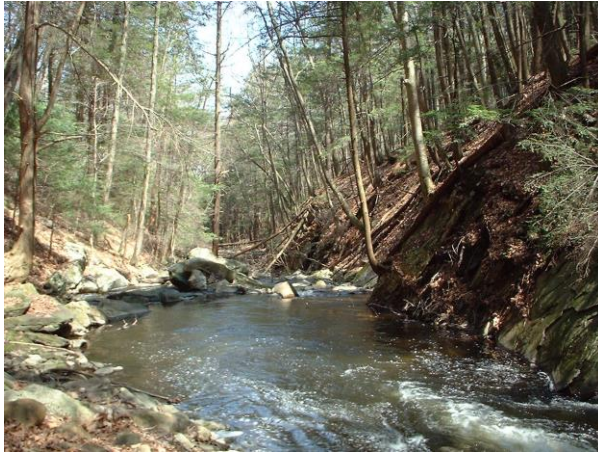
Flows and water quality in the Broad Brook are sufficient to support a Spring trout fishery.

Broad Brook has great potential for use as a recreational trout fishery in the Buxton Gorge area. There is already a reproducing brown trout population as indicated by DEC sampling in 1995 that yielded four small brown trout (under stocking size) at the Buxton Road Bridge (site # 1). Conversations with DEC personnel indicate they have never stocked Broad Brook so all trout

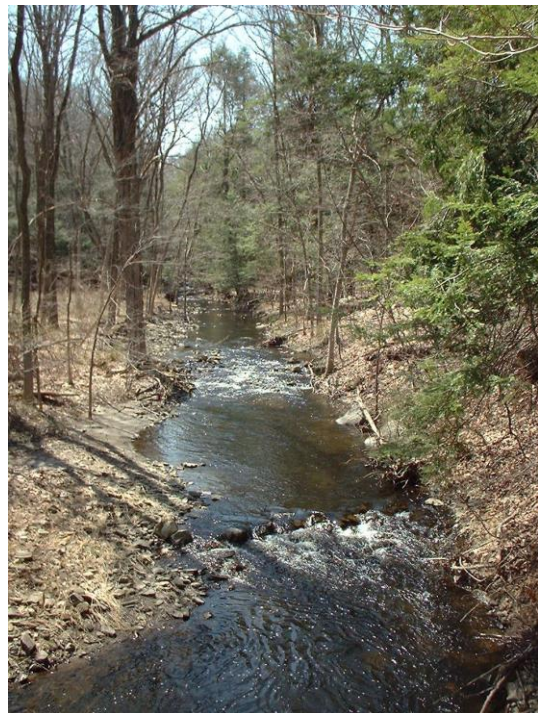
***Potential site of new footbridge
below Gorge***

B. A trail network exists and can be further delineated and expanded upon. Creation of a new group of trails on the east side of the brook would allow visitors scenic views of the Gorge while preventing erosion created by trails on steep slopes. This eastern portion is distinctly different from other portions of the property. Although it is possible to create a trail on this side of the brook that is exclusively on Buxton property, it is recommended that the trail be constructed partially on State property so that it is farther up the slope. This would require moving back the fence from the 684 rest area to accommodate the new trail. This would open up the other side of the Gorge for a trail so that a loop trail with two bridges could give walkers fantastic views of the Gorge. Standing on the bridge and watching the spring torrent of water through the Gorge would be an impressive sight.

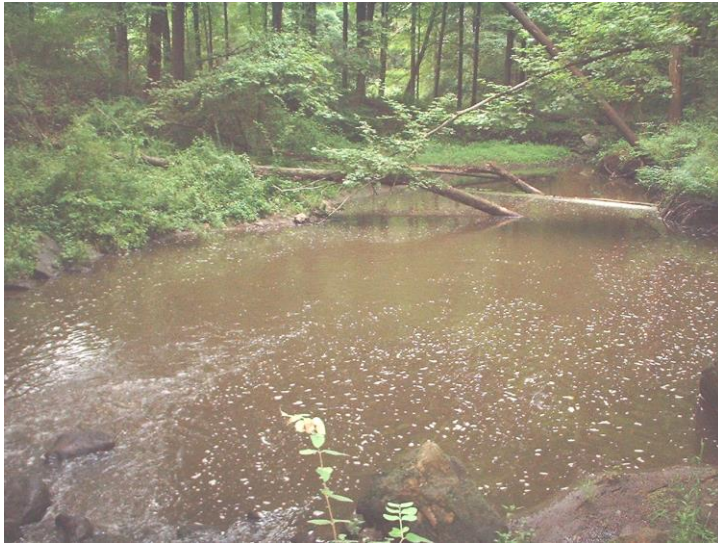
1. Control of silt from road runoff in the upper watershed will improve aquatic habitat and improve water quality. During rains the Broad Brook is heavily laden with silt from sources in the upper watershed .

Pool just below Buxton road after rain storm

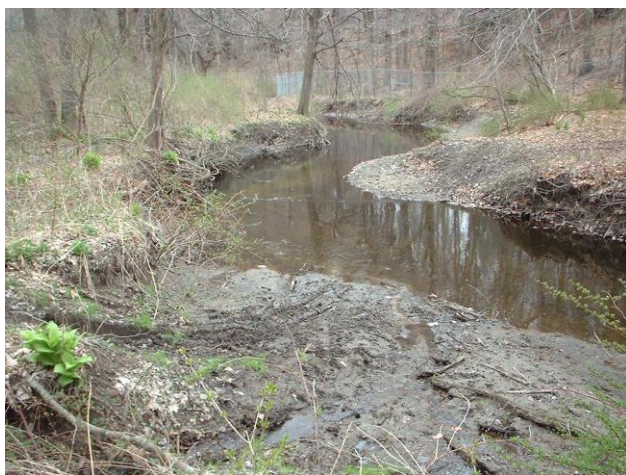
2. Control of all-terrain vehicle access and repair of stream crossing area – All-terrain vehicle/mountain bike access from interstate 684 crosses the stream and enters the southern wetland area of Buxton property. Blocking of this access and repair of the banks of the stream would help restore trout habitat and prevent silt from washing into the stream.

Stream crossing area

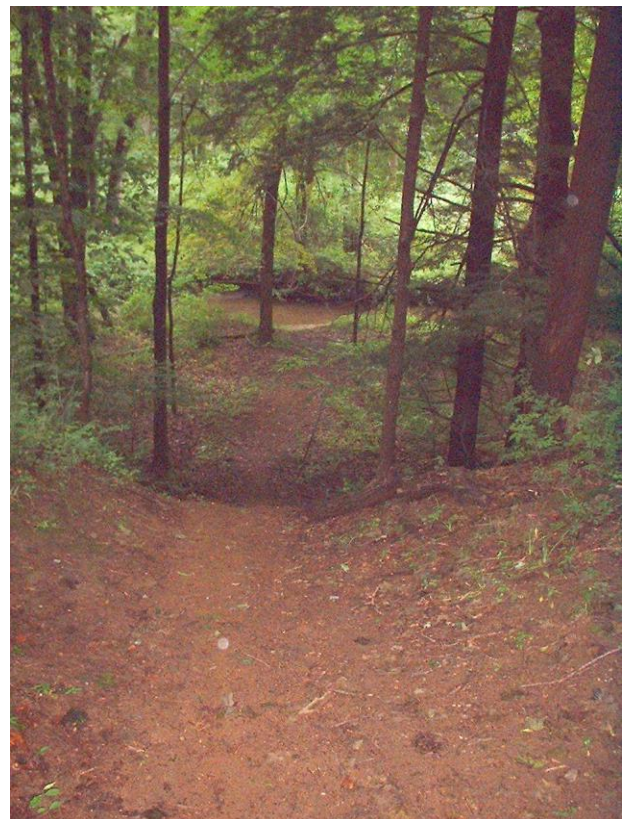
Bike trail from 684 rest area through stream to wetland on other side

recommend removing. The trail from the southern end of the 684 rest area is a conduit for mountain bikes and other undesirable activity. It also continues across the brook and into the wetland area. Removal of this trail and its connecting trail to Buxton (just south of the bridge) would help curtail this type of activity. It also would keep trails away from the fragile vernal pond. Repair of the holes in the 684 fence would also help stop some of these activities.

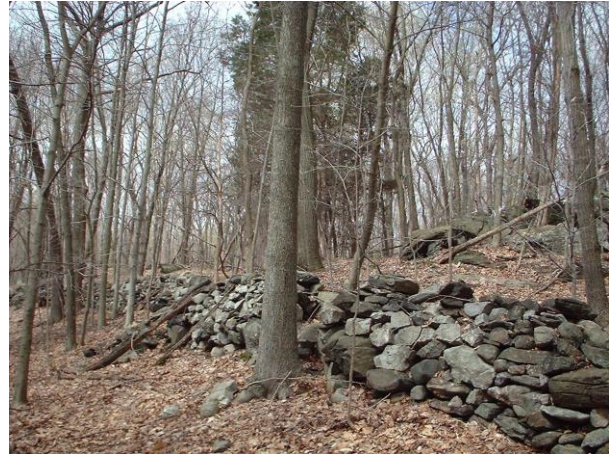
3. The Buxton property has a wonderful assemblage of stone walls. When this area is opened to the public there is a greater chance of stones being stolen and walls disappearing. If stones that have fallen off walls were put back there would be less chance they would be stolen. This minor repair could also keep the walls standing for another hundred years.

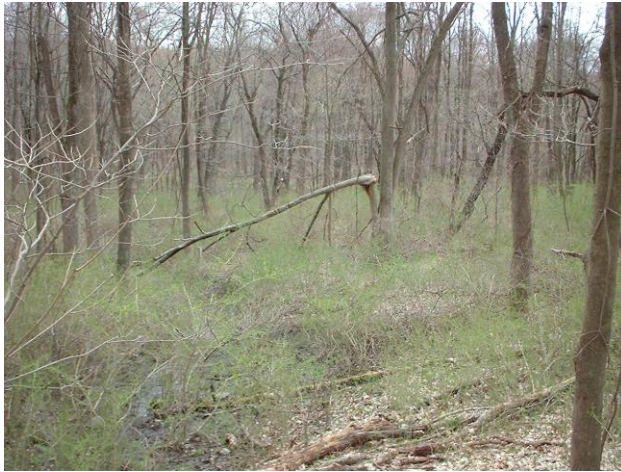
4. Although the site has many non-native invasive species, it is not recommended that these be removed. Not only would it be an extremely large job, but it would destroy much of the existing habitat in the wetland areas.

Non-natives leaf out earlier than natives and so are easily visible in springtime.

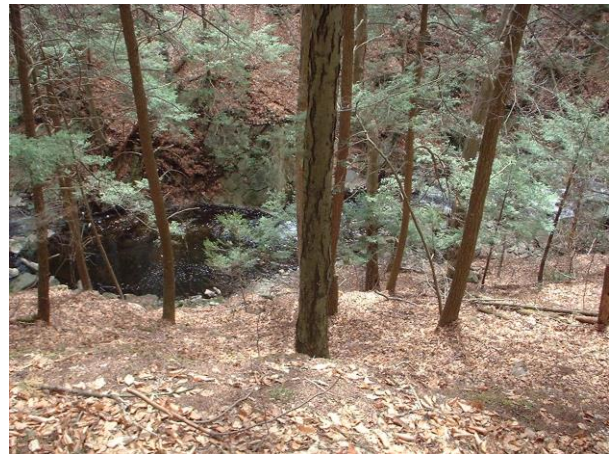
5. Restoration of areas where walkers have made trails down the steep slopes is important to prevent erosion and runoff.
